DETERIORATION  
OF STRUCTURES IN  
SEA-WATER  
FIRST REPORT OF THE  
COMMITTEE OF THE INST. C.E.

COMMITTEE  
OF  
THE INSTITUTION OF CIVIL ENGINEERS  
APPOINTED TO INVESTIGATE  
THE DETERIORATION OF STRUCTURES  
OF TIMBER, METAL AND CONCRETE  
EXPOSED TO THE ACTION OF  
SEA-WATER

*FIRST REPORT OF THE COMMITTEE*

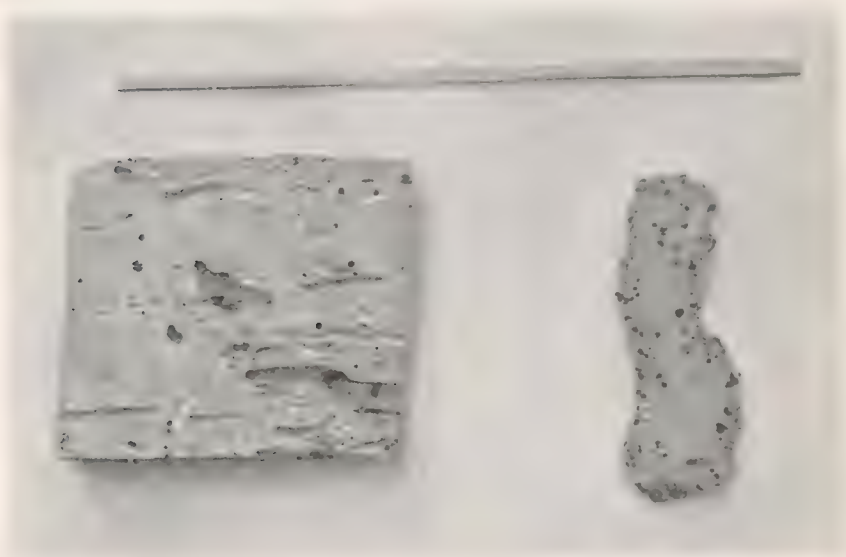
SECTIONS OF A PILE IN EAST WHARF SHOWING TEREDO ACTION.

Original section of pile about 13 inches  $\times$  13 inches. Length of specimen about 2 feet, cut out of pile between levels of 3 feet 6 inches and 5 feet 6 inches above L.W.O.S.T. Holes range up to  $\frac{3}{4}$ -inch diameter. Description of timber, Ballow. Age of timber, piles driven 14 years ago.

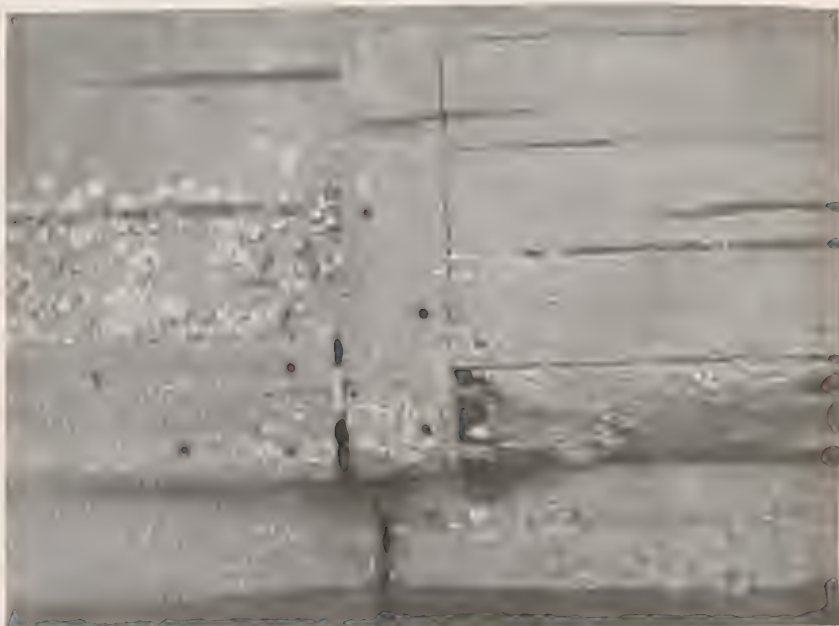
Ballow fendering at knuckle on West Wall of Entrance Channel, Graving Dock, August, 1917.

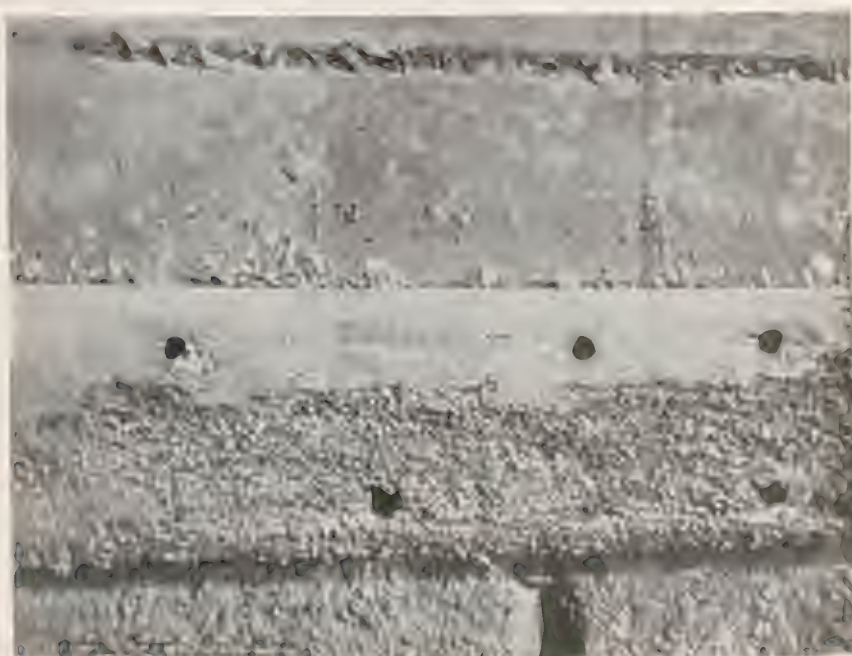
Timber fendering on West Wall of Entrance Channel, Graving Dock, August, 1917.

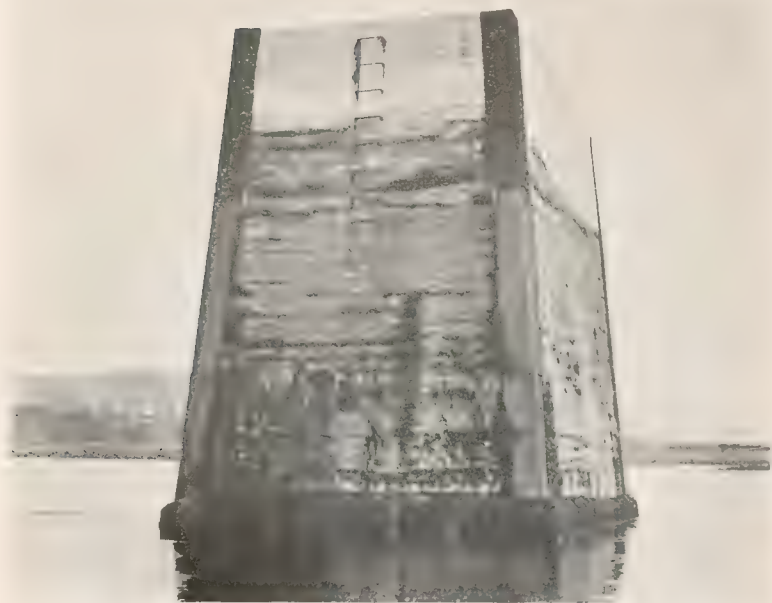
(b) had it been possible to prevent floating ice from touching the piers, they would have shown almost as much deterioration as they have suffered under the two influences of surface freeze and thaw, and the impact of ice. The maximum depth to which the concrete has been removed is about 15 inches, and this depth is reached in very few places only. The average depth is less than 6 inches, so that the actual diminution of bulk is inconsiderable. It is a singular, but unmistakable, fact

PIER No. 3. FROM DOWN STREAM. 19th October, 1916.  
Built 1909-10. Concrete, May and June, 1910.

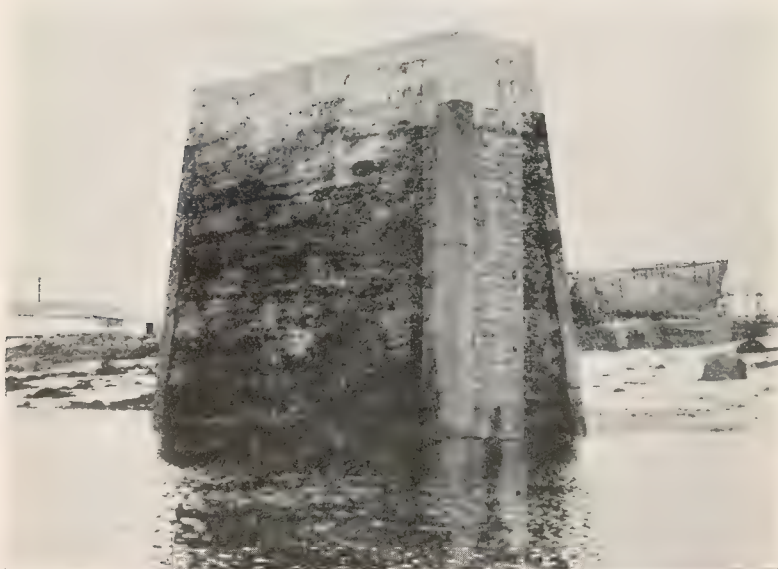
PIER No. 1. FROM DOWN STREAM. 19th October, 1916.  
Built 1909-10. Concrete, May and June, 1910.

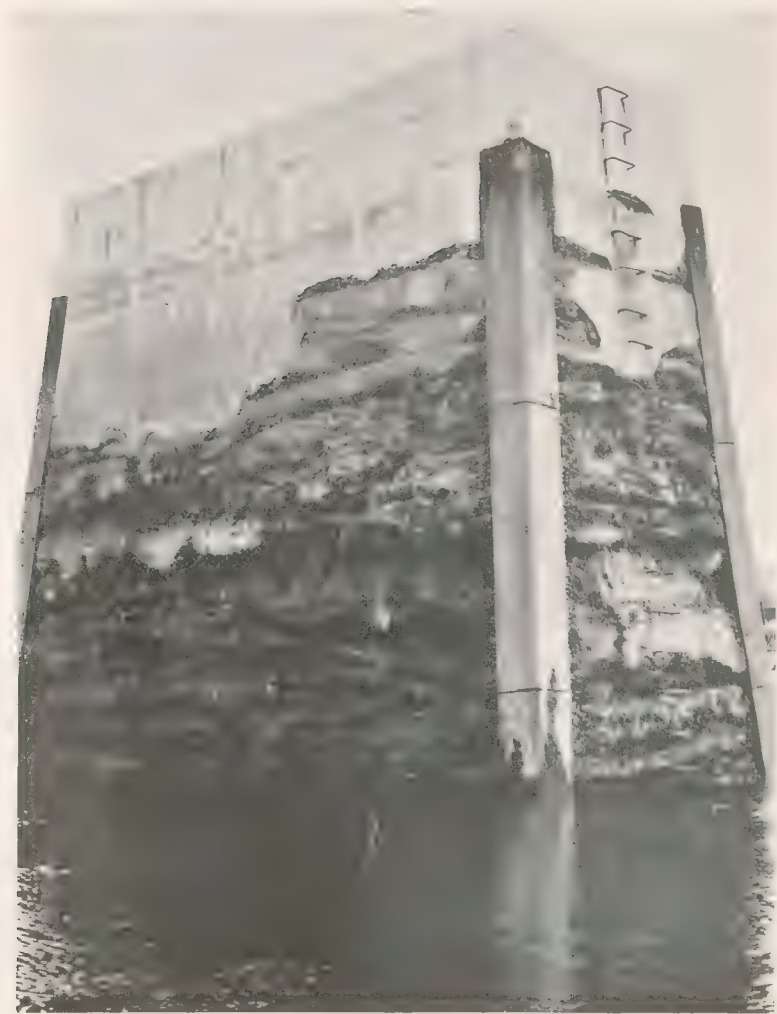
PIER NO. 2. FROM DOWN STREAM. 19th October, 1916.
